**Child Care Center  
PR0023ZZ**

**150 Chardon Ave., Hato Rey, Puerto Rico**

**Post-Earthquake Assessment**

**January 28, 2020**

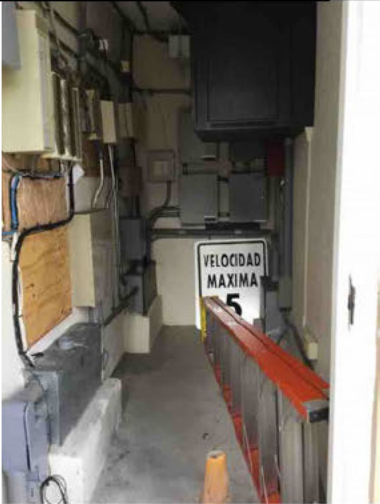
6 1/13/20

cab net anchored to structural wa .

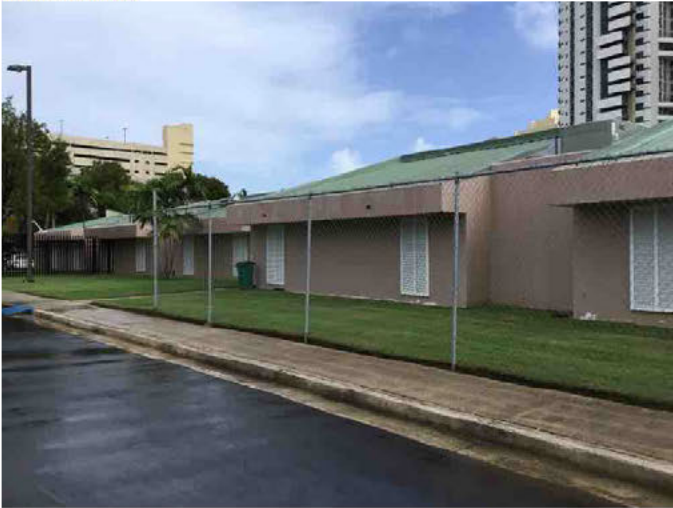
16 + 1/13/20

West facade.
